# SOFTY 1 Memory Map

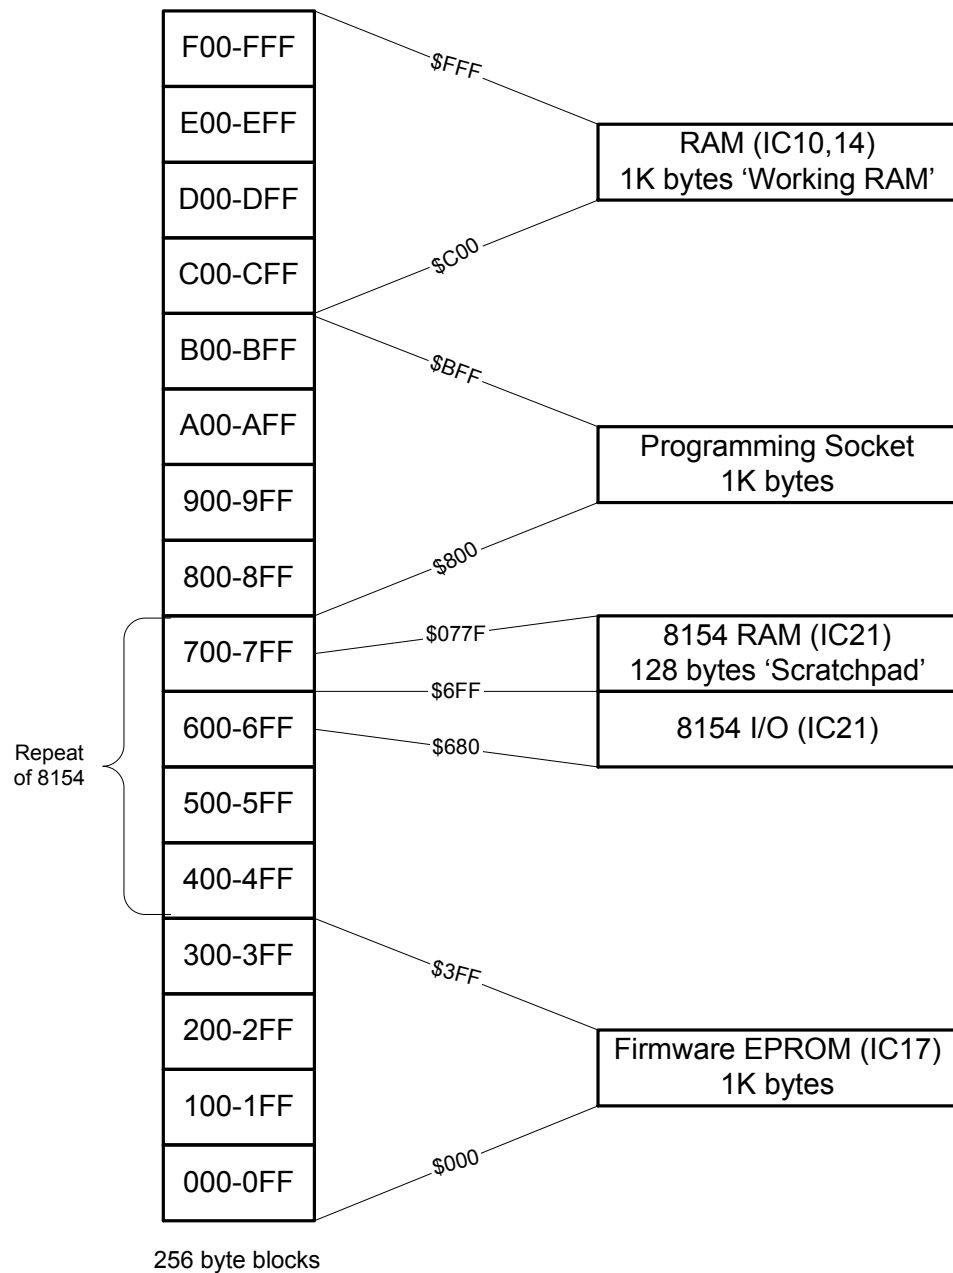
- A7 driving the 8154 M/I/O pin is inverted hence RAM and I/O are swapped from normal.
- The 8154 repeats 4 times because of incomplete address decoding, typically addressed as shown here.
- Only half of 'Working RAM' is displayed on the screen at any one time.
